INVESTIGATION OF ROOTZONE SALINITY WITH FIELD MONITORING SYSTEM AT TSUNAMI AFFECTED RICE FEILDS IN MIYAGI, JAPAN

Key words: Field Monitoring System, TDT sensor, Tsunami affected soil

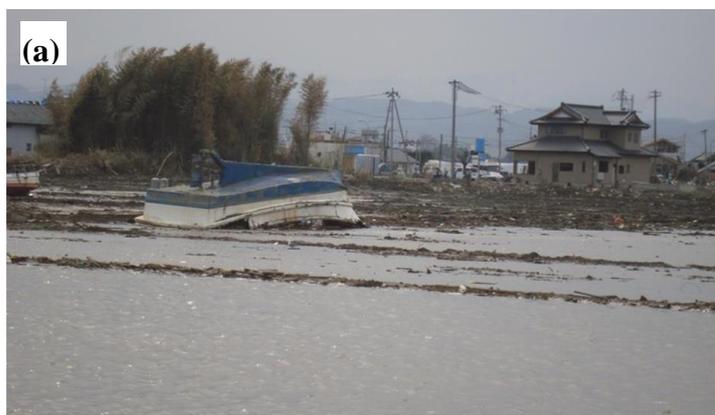
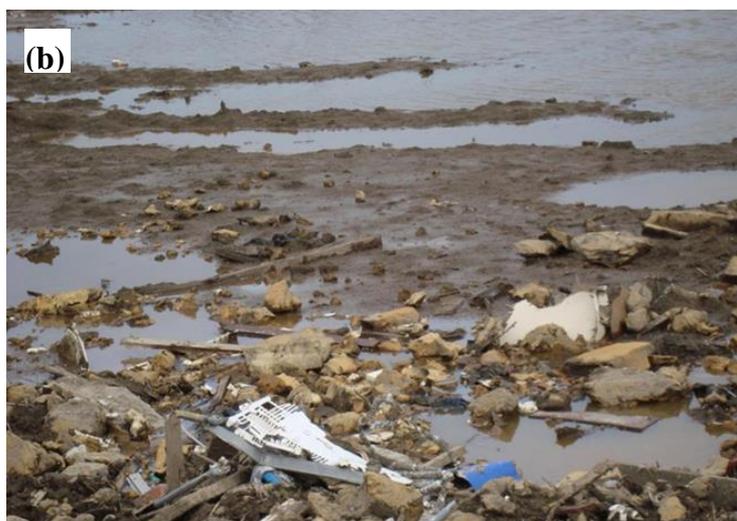
Fig. 1 Photograph of the damaged farmlands in Natori, Miyagi on 26 April 2011: (a) Tsunami inundated areas and (b) massive amount of debris (JSIDRE, 2011).

The 11 March 2011 M9.0 megathrust earthquake off the East Coast of Japan (Fig. 1a) (e.g. Ozawa et al., 2011; Sato et al., 2011) generated a devastating tsunami that inundated over 1300 km of the Pacific Coast, and reached more than 5 km inland in some areas of the Sendai Plain in Miyagi, Japan (Chagué-Goff et al., 2012). The tsunami caused extensive damage to thirteen thousand hectares of farmlands, which contained collapsed houses, buildings and many types of infrastructure (Earthquake and Reconstruction Division of Miyagi Prefecture, 2014). Sendai Plain, which Sendai airport is located, was the place to recover the infrastructure after the disaster. In April 2011, some surveys reported the situation of paddy fields to assess the environmental impacts of tsunami inundation at the areas of Sendai Plain (Fig. 1a and 1b) (JSIDRE, 2011). In May 2011, ponded water was still recorded in many rice paddy fields and in 45 depressions up to 2.6 km inland north of Sendai Plain, and salt crusts were also observed on many paddy fields, where water had evaporated and/or leached into the soil (between ~1.2 km and ~3.5 km inland) (Chagué-Goff et al., 2012).

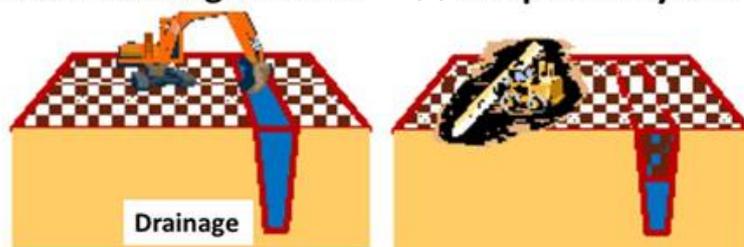
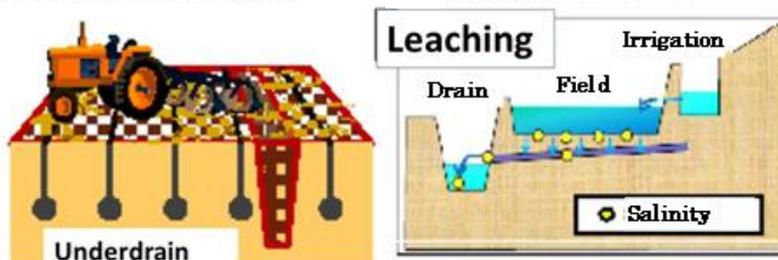
Fig. 2 Schematic figures of recovery process of agricultural fields after the disaster (MAFF, 2011).

(a) Recover drainage trench (b) Strip salinity soil

(c) Create underdrain (d) Desalinization

With the guideline of desalination process proposed by MAFF (2011), the first comprehensive attempt to recover the devastated paddy fields was carried out (Fig. 2).

50 Some eighty percent of the damaged farmlands have been recovered in the whole
damaged areas of Miyagi (Earthquake and Reconstruction Division of Miyagi
Prefecture, 2014) (Fig. 2a and 2b), although underdrains, which can remove salinity
under saturated soil condition, have been installed at a part of recovered paddy fields
(Fig. 2c and 2d). Chiba et al. (2012) investigated the effect of underdrains on
55 desalination process due to rainfall in paddy fields in Sendai Plain with/without
underdrains, suggesting that underdrains facilitated the desalination during rainy season
between June and September. However, subsidence and high salinity groundwater,
making it difficult to completely remove salinity from the soil near the coastal side all
over the Miyagi (Chiba et al., 2015).

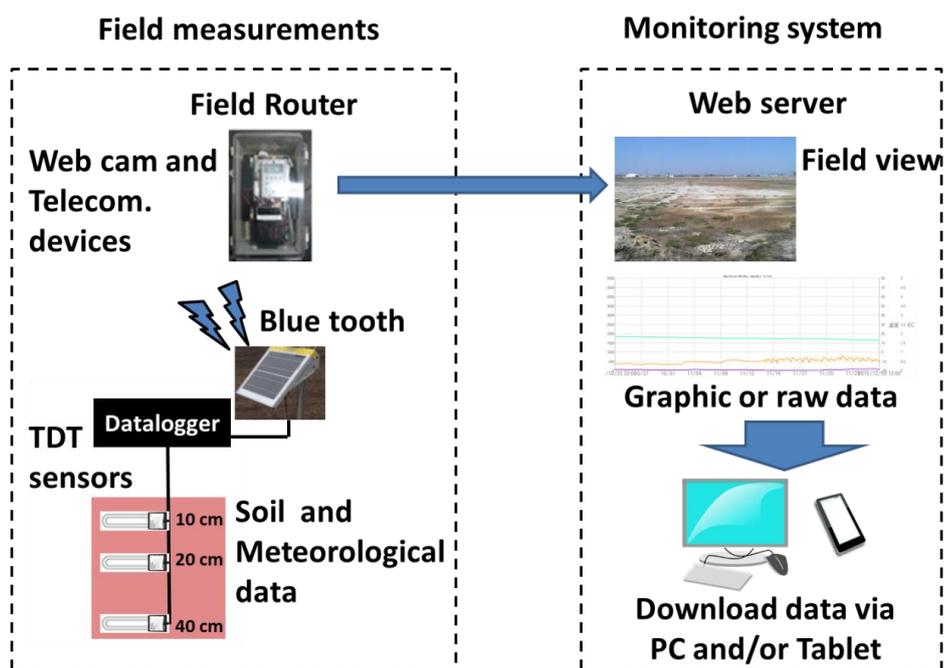
395 Fig. 3 Diagram of the FMS for remote sensing technique to measure environmental factors (soil moisture, bulk EC, etc.) at the Tsunami affected agricultural fields.

60 Field Monitoring System (FMS) to measure soil moisture and salinity
developed by Mizoguchi et al. (2012) can facilitate recovery of agricultural production
on damaged lands (Fig. 3). The FMS contains three main components: data loggers
(Decagon Device and/or Campbell Sci.), soil/meteorological sensors, and a field router
(FR)(X-ability), allowing us to collect the in-situ data through Bluetooth and send it to
65 the data server over the Internet. The FR mainly consists of a micro-PC, 3G/GSM USB
modem, webcam, and battery in a waterproof dust-tight box. The FR consumes little
power (six-watt solar panel), is easy to set up, and transmits data inexpensively over a
cellular mobile line. With the FMS, Chiba et al. (2012) monitored electric conductivity
(EC) of groundwater and groundwater level successfully. However, monitoring high
70 soil water content (θ) and high bulk EC caused by salt leaching and saltwater intrusion

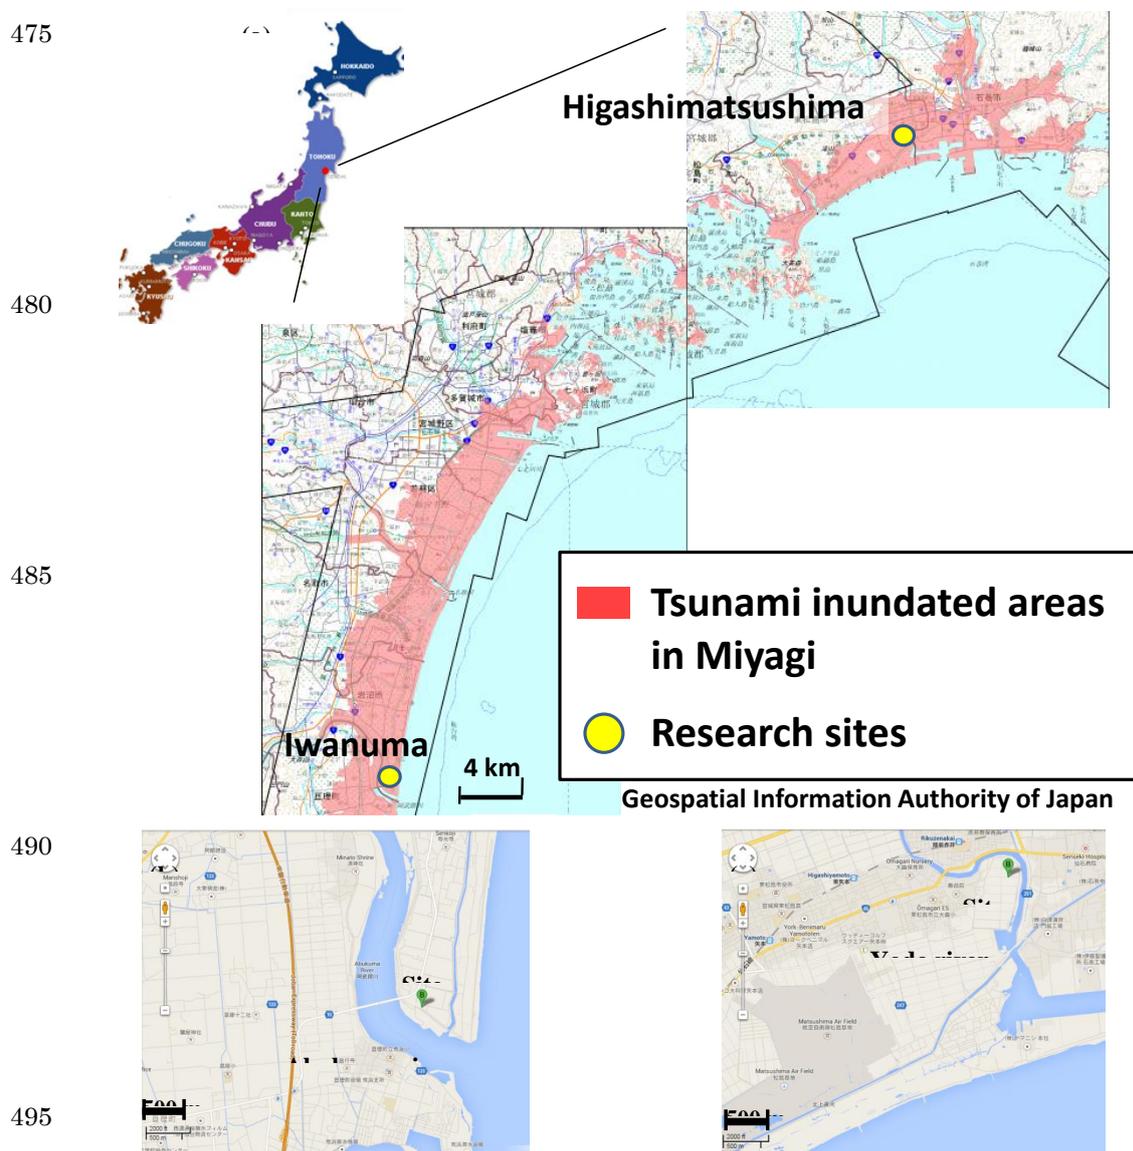
Fig. 4 Experimental sites near the costal side in Miyagi, Japan. The map showing inundated areas of the Tohoku earthquake and massive tsunami (Geospatial Information Authority of Japan).

(38°25'38.6"N 141°14'46.4"E) in Miyagi, Japan (Fig. 4). The paddy fields in Iwanuma
100 are located at a costal side, 0.7 km and 0.25 km away from the Pacific Ocean and
Abukuma River estuary, respectively (Fig. 4a). After the disaster, co-seismic subsidence
of 17-21 cm of the land was reported by Ozawa et al. (2011), and the area was covered
by the top of 10 cm thick sediment layer consisting of sand and/or mud (Chiba et al.,
2012). The geomorphology of the low-lying coastal land prevented much of the
105 seawater from draining away, resulting in water ponding for 20 days. In 2013, drainage
trench and canals in the area were recovered, and deposition of debris such as woods
and rock fragments was stripped from the soil surface. However, much of the area near
Iwanuma has high EC of groundwater due to the low sea level (approximately 0 m). In
Higashimatsushima, the tsunami damaged area (3600 ha) consisted of 40% farmlands,

In the summer of 2014, we began a study at the sites (Iwanuma and
150 Higashimatsushima) to monitor soil moisture and bulk EC using FMS with TDT
sensors (Acclima) (Fig. 4b and 4c). Three TDT probes were installed at depths of 10, 20,
and 40 cm. TDT measurements were recorded every 1 h by a model CR800 datalogger
(Campbell Scientific, Logan, UT) and uploaded at the data server at noon through the
FR (X-ability). Groundwater level (G.W.L.) and EC of groundwater were measured
155 with a CTD sensor (Decagon Devices), hooked up with a Em50 datalogger (Decagon
Devices). The CTD sensor was placed in a well at a depth of 50 cm from the soil
surface.

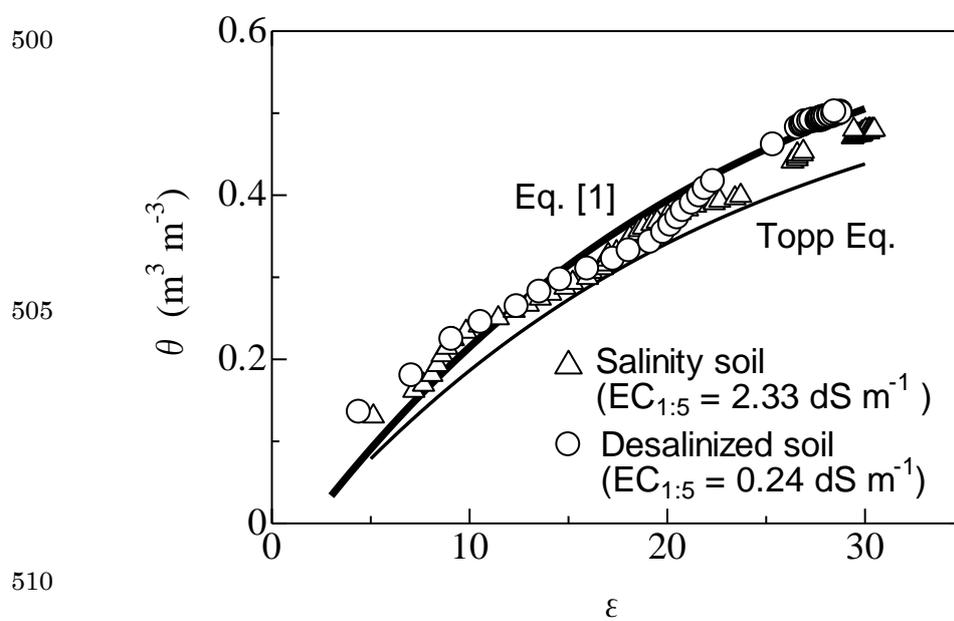
400 Fig. 5 TDT sensor calibration using a Tsunami affected soil and desalinated soil.

160 The relationship between ε and θ , obtained with salinity ($EC_{1.5} = 2.33 \text{ dS m}^{-1}$)
and desalinized soils ($EC_{1.5} = 0.24 \text{ dS m}^{-1}$) from Higashimatsushima, was very close,
although θ ($\varepsilon > 21$) of the salinity soil was slightly higher than the desalinized soil (Fig.
5). When saturated θ for the soil was $0.55 \text{ m}^3 \text{ m}^{-3}$, bulk EC of the desalinized soil was 6
 dS m^{-1} , which caused a considerable measurement error (ε was equal to zero). However,
165 we did not find such errors in the desalinized soil of Higashimatsushima at saturated
condition. Likewise, no error readings occurred in the salinized soil of Iwanuma ($EC_{1.5}$
 $= 2.33 \text{ dS m}^{-1}$), resulting in a threshold of 6 dS m^{-1} for those tsunami affected soils.

Measured ε - θ relationship was nearly identical to Topp Eq. (Topp et al., 1980),
but Topp Eq. slightly underestimated θ (Fig. 5). For more accurate θ estimation, we
170 applied a multiplier of -1.15, obtained by a regression analysis to Topp Eq., yielding the
equation

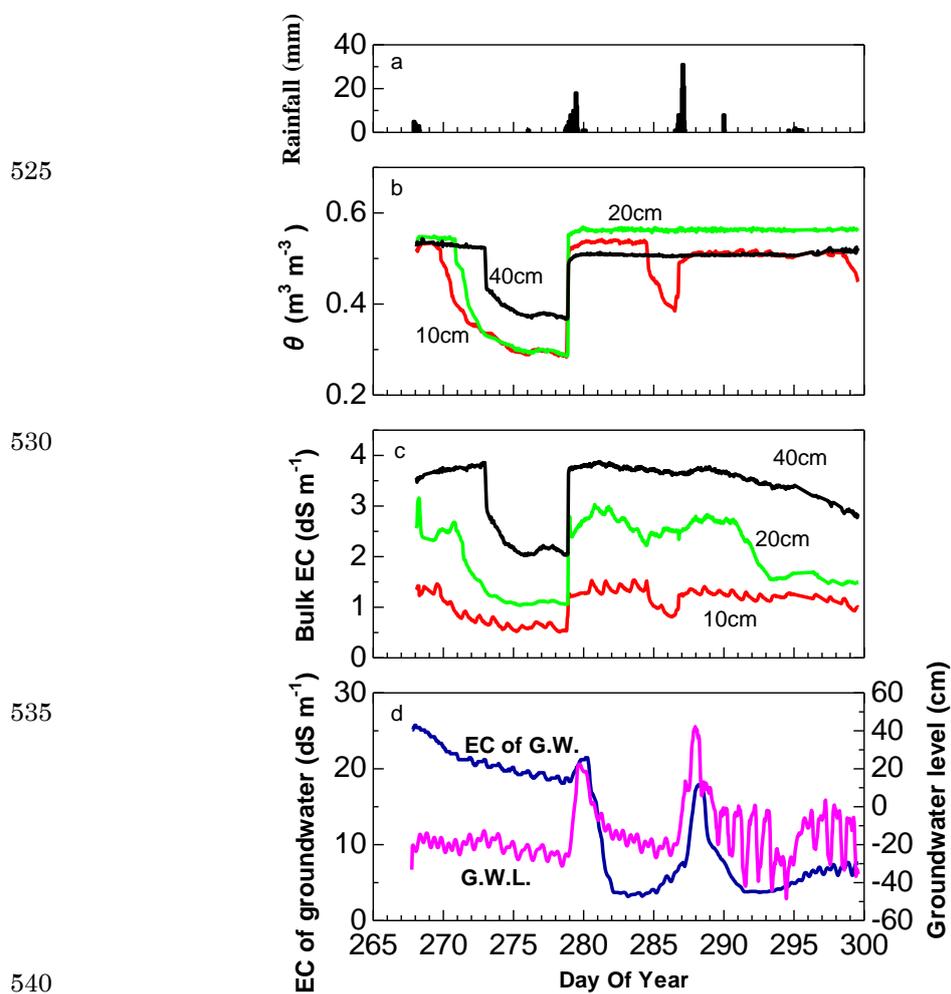
Fig. 6 Temporal changes in rainfall (a), water content (b), bulk EC (c), and EC of groundwater (d) at the tsunami affected agricultural field in Iwanuma, Miyagi, Japan.

In October 2014, the Iwanuma region was hit by two typhoons, caused rainfall events over 112 mm, while typhoons are rare (Fig. 6a). Soil water content drastically increased at depths of 10, 20, and 40 cm on 5 October and θ below 20 cm depth was saturated for 20 days (Fig. 6b). Saturated hydraulic conductivity was 0.35 and 9.76 cm
180 d^{-1} at depths of 15 and 25 cm, respectively. Bulk EC increased with increasing θ , and the highest bulk EC was 3.7 dS m^{-1} at a depth of 40 cm (Fig. 6c). Shallow groundwater level also increased up to 20 cm and 40 cm above the soil surface on 5 October and 13 October, respectively (Fig. 6d). An example of webcam photos showed the ponding condition after the heavy rainfall on 5 October (Fig. 7), suggesting that EC of
185 groundwater decreased from 22 dS m^{-1} to 5 dS m^{-1} due to a direct inflow into a well. For this reason, increase in EC of groundwater was found after 5 October (Fig. 6d). This indicated the intrusion of salt wedge into the groundwater, which has a seasonal cycle of salinity variation due to the strongly seasonal rainfall.

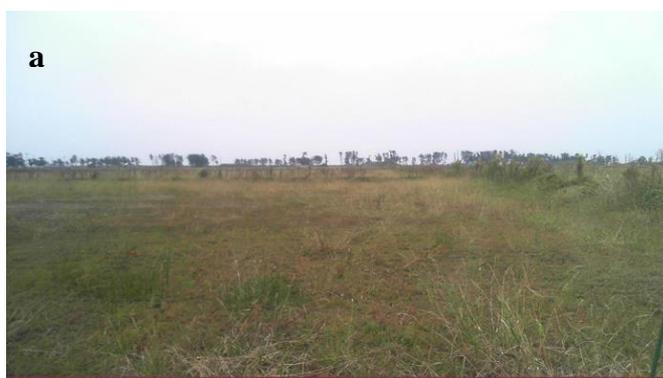
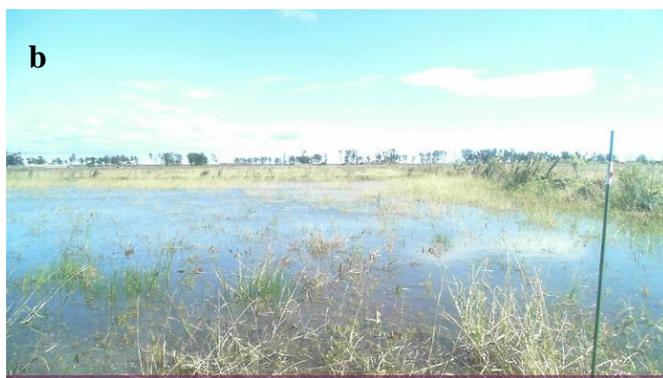
Fig. 7 Webcam pictures of the Iwanuma site on the day before-and-after Typhoon in 2014.

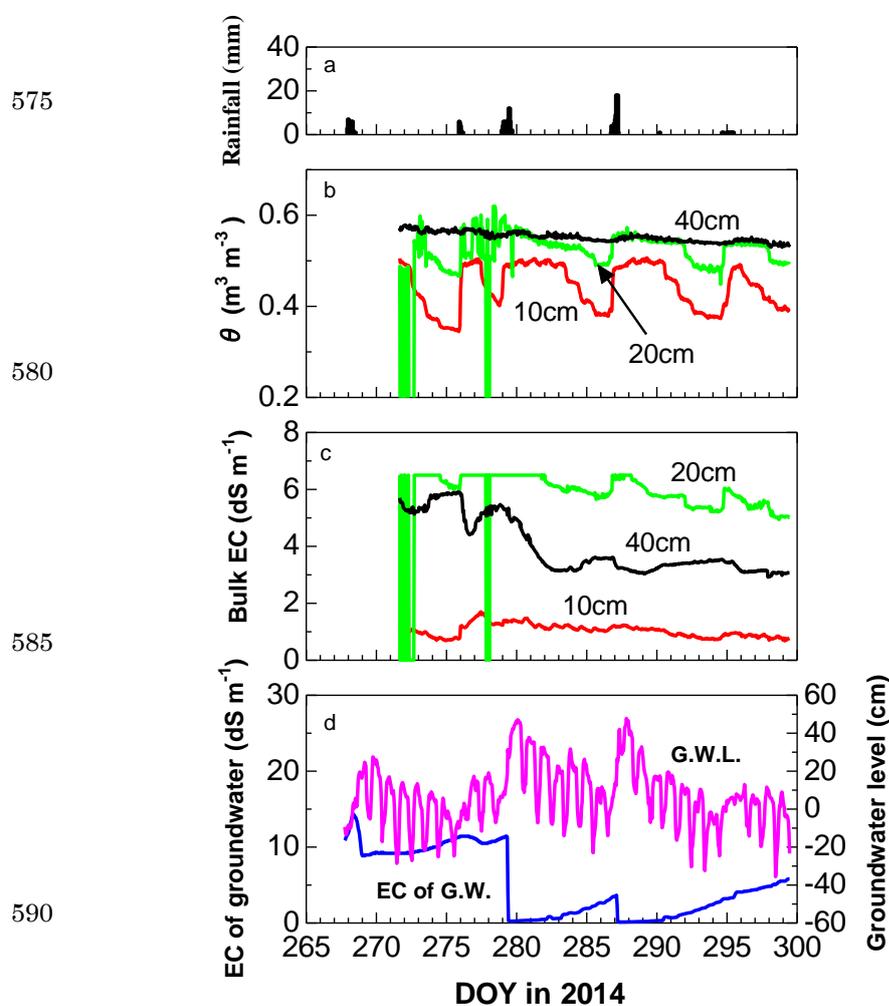
405 Fig. 8 Temporal changes in rainfall (a), water content (b), bulk EC (c), and EC of groundwater (d) at the tsunami affected agricultural field in Higashimatsushima, Miyagi, Japan.

215 During October 2014, total rainfall was 211 mm (Fig. 8a), and θ was
completely saturated at a depth of 40 cm (Fig. 8b). Bulk EC at a depth of 20 cm
exceeded 6 dS m⁻¹, which was the maximum detectable value of EC with TDT sensors
(Fig. 8c), resulting in error of θ measurements at the same depth. This suggests that

coated TDT probes would be required to monitor θ in such high salt concentration. To
220 decrease salt concentration near soil surface, daytime pumping was operated (Fig. 8d).
A mismatch of daily variations between groundwater level and unsaturated θ condition
may be explained by low saturated conductivity of the soil ($K_s = 1 \text{ cm d}^{-1}$). Without
exceptions of indirect inflows after typhoons, however, EC of groundwater was about
10 dS m^{-1} at a depth of 50 cm.

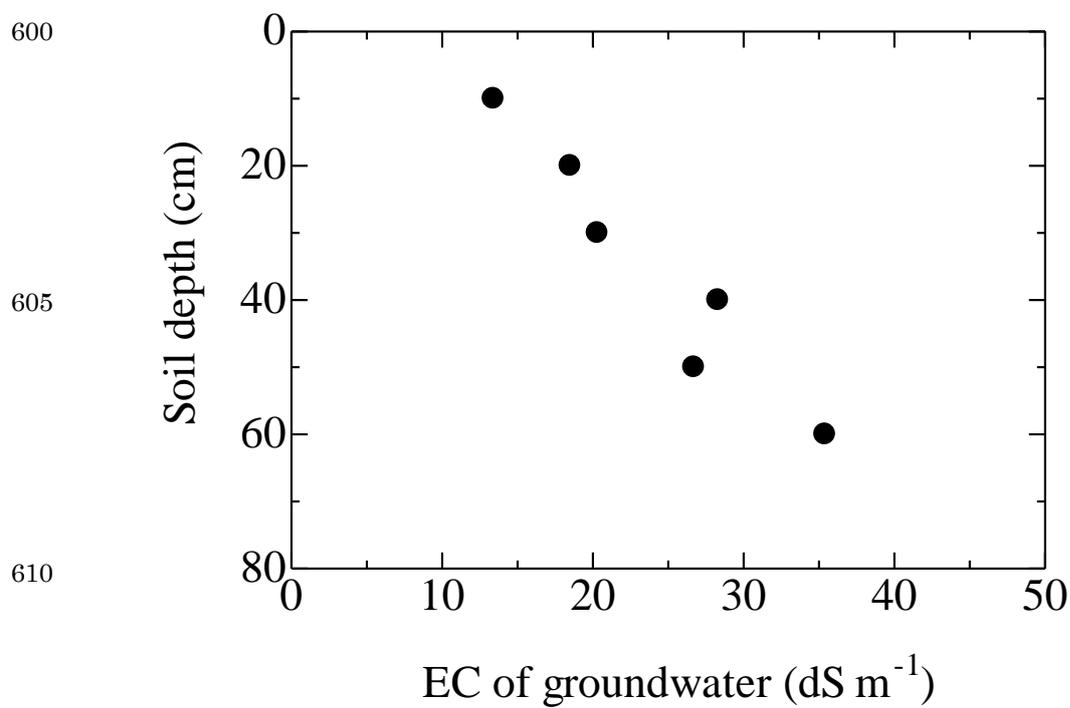
Fig. 9 Profile of EC of groundwater on 9 September 2013 when groundwater level was 5 cm depth.

225 Locally, we confirmed the trend of bulk EC decline from 9.4 dS m^{-1} to 2.44 dS
 m^{-1} near the soil surface, indicating the effect of rainfall leaching through 2 yr-period,
but we found that the subsidence of 60 cm in Higashimatsushima made it difficult to
remove salt movement from salty groundwater in freshwater-saltwater environments of
the Pacific Coast. Comparison of groundwater level in the Higashimatsushima with
230 Iwanuma sites showed that Higashimatsushima site was flooded more frequently, even
though the site was covered with tsunami deposit of 50 cm. The profile of EC of
groundwater increased linearly as soil depth increased (Fig. 9). As we mentioned,
rainfall could maintain the freshwater zone to decline soil salinity near the soil surface.
However, it seemed that increase in salty groundwater level caused salination below the
235 soil surface. This explained why the shallow groundwater could be salinity source to the

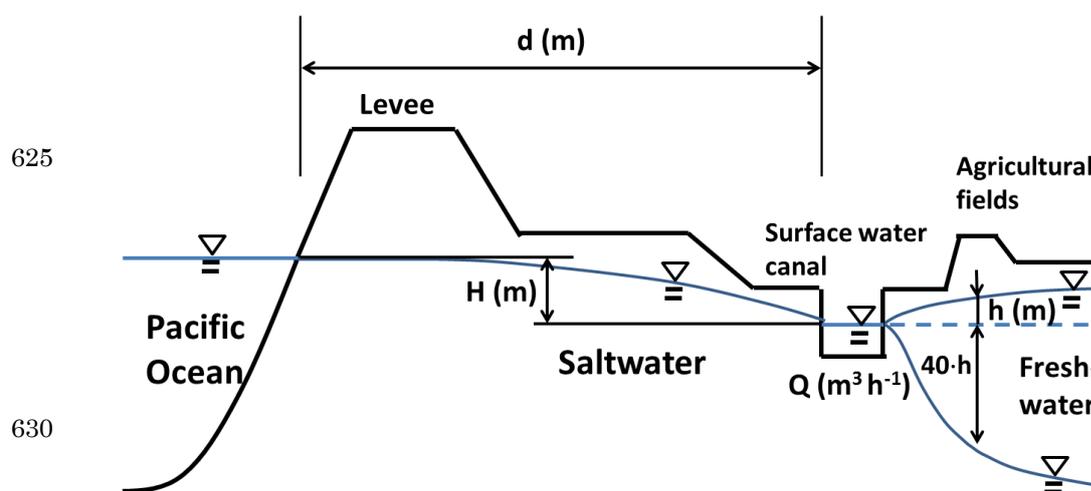
410 Fig. 10 The surface water canal and levee system to control saltwater intrusion from the costal side.

For control of saltwater intrusion, the surface water canals and levee system
was proposed to convey freshwater from inland water conservation (storage) areas to
250 coastal areas, where the water is recharged through the canals to the underlying aquifer
to slow saltwater intrusion in the aquifer (Barlow and Reichard, 2010). In addition to the
conventional method, an innovative approach is being proposed to manage saltwater
intrusion along the Pacific coast (Ota et al., 2013; Sasaki, 2014), which is the technique
to maintain freshwater zone under the tsunami affected agricultural fields. Figure 10
255 shows the schematic figure of the surface water canal to show the amount of surface-
water canal, Q ($\text{m}^3 \text{h}^{-1}$) (Sasaki, 2014):

$$Q = \frac{N \cdot H^2 \cdot L}{2d} \quad [3]$$

where N is hydraulic conductivity (m h^{-1}), H is water level difference between the
Ocean and canal, L is length of the canal, and d is distance between the ocean and canal.
